RESEARCH MEMORANDUM

FULL-SCALE PERFORMANCE STUDY OF A PROTOTYPE CRASH-
FIRE PROTECTION SYSTEM FOR RECIPROCATING-
ENGINE-POWERED AIRPLANES

By Dugald O. Black and Jacob C. Moser

Lewis Flight Propulsion Laboratory
Cleveland, Ohio

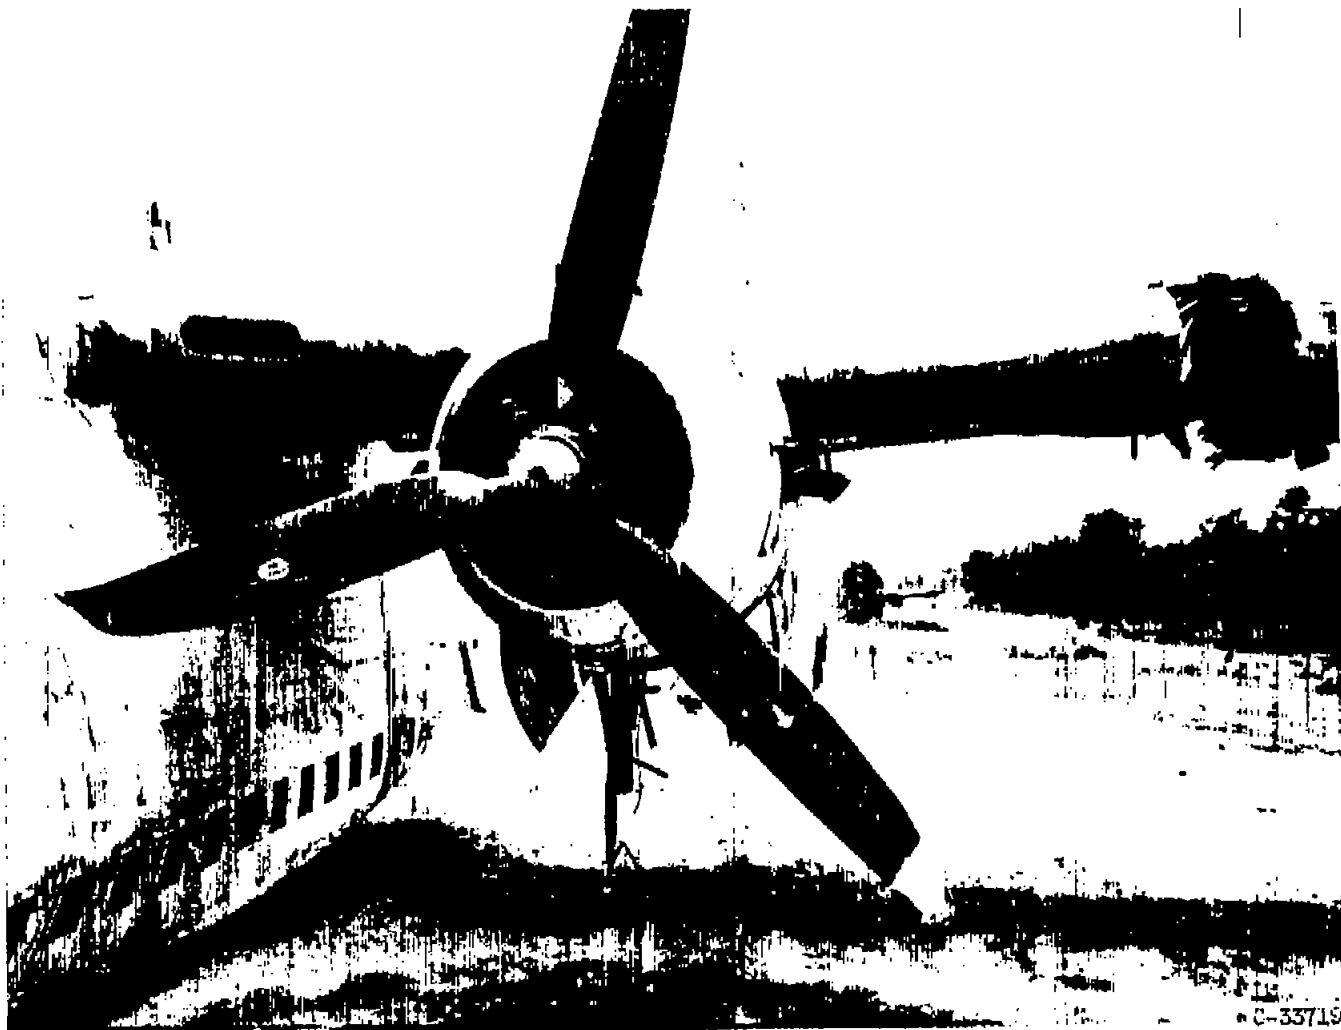
(b) Left engine.

The propellers of both the right and the left engines were bent from impact with the crash barrier as shown by photographs in figures 3(a) and (b), respectively.

Figure 3. - Concluded. Propeller damage produced by crash barriers.

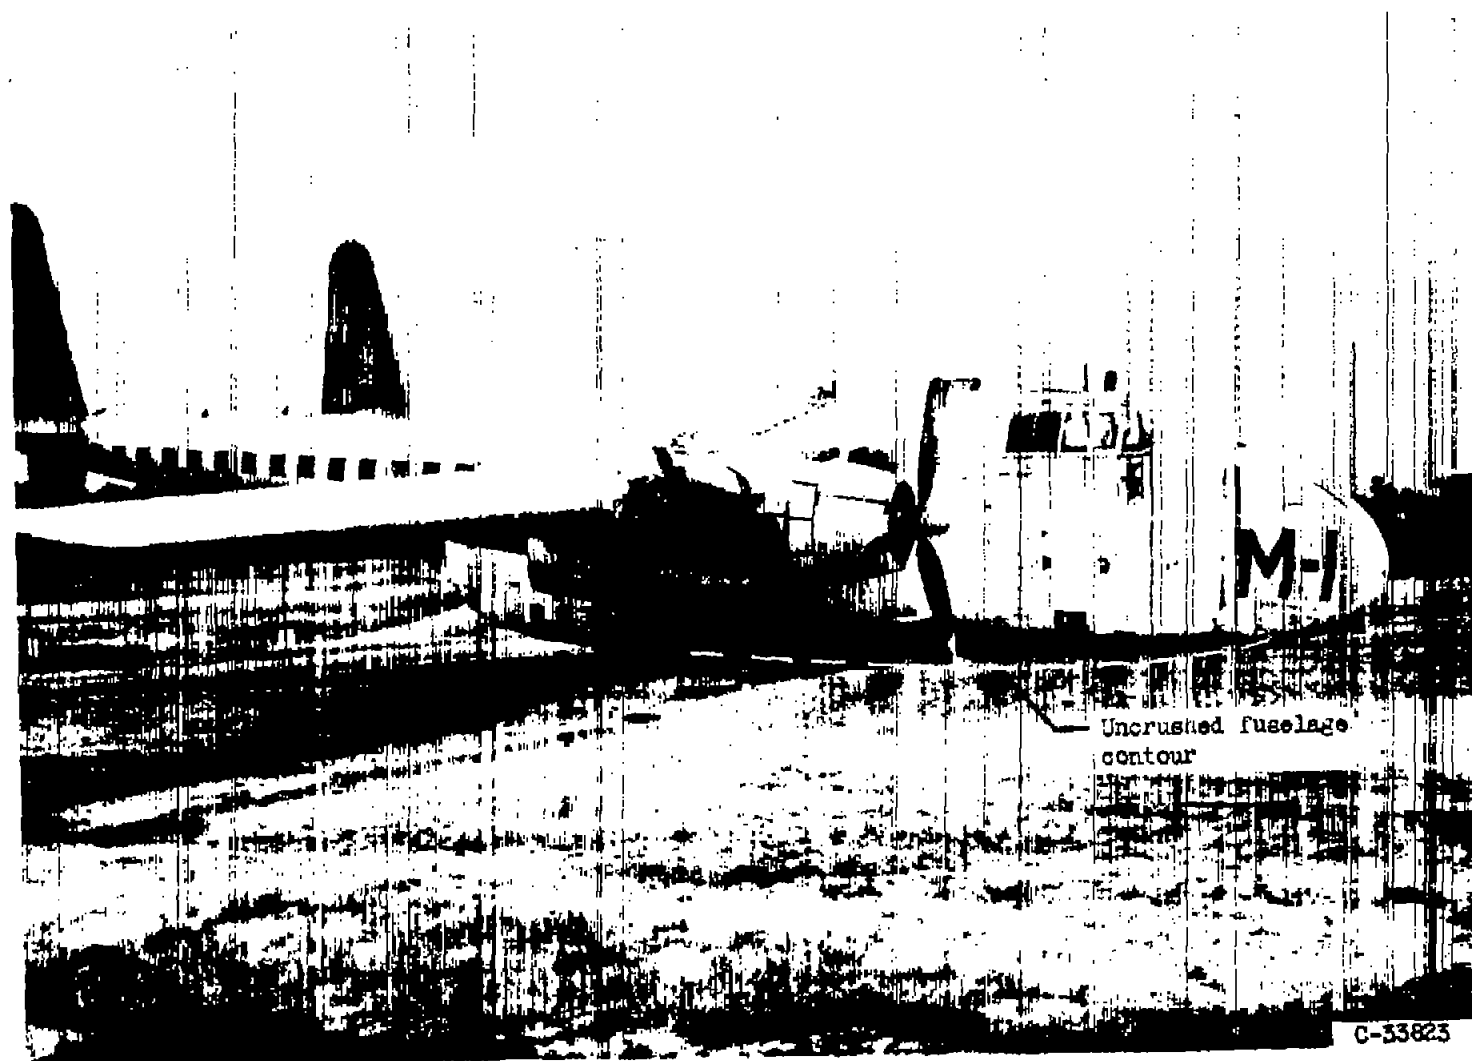
(a) Right side.

The amount of fuselage crushing that occurred during the crash is shown in the photographs of the right and left sides of the airplane in figures 8(a) and (b), respectively. The dotted lines in each figure define the original contour of the fuselage before the crash. In order to determine the extent of the crash damage to the skin and structure on the belly of the airplane, the fuselage was jacked up and examined. Figure 9 is a front view of the fuselage belly showing the damage to the skin and structure. The large opening in the center of the fuselage belly is the nose-gear well. The damage directly behind this opening was caused by the nose-gear strut's being driven rearward by impact with the ground and by the subsequent slide of the airplane. The skin and structure on each side of this opening was twisted and ripped. A front view of the nose gear and front bulkhead in figure 10 shows the structural damage to the bulkhead to which the nose-gear assembly was attached. This entire bulkhead was torn loose by the nose gear as it was driven rearward for approximately 9 feet by the force of the crash. Figure 11(a) shows the buckled floor and the structural damage in the left front portion of the cargo compartment. Damage to the structure in the right front portion of the cargo compartment is shown in figure 11(b).

Figure 8. - Crash-damaged fuselage of airplane.

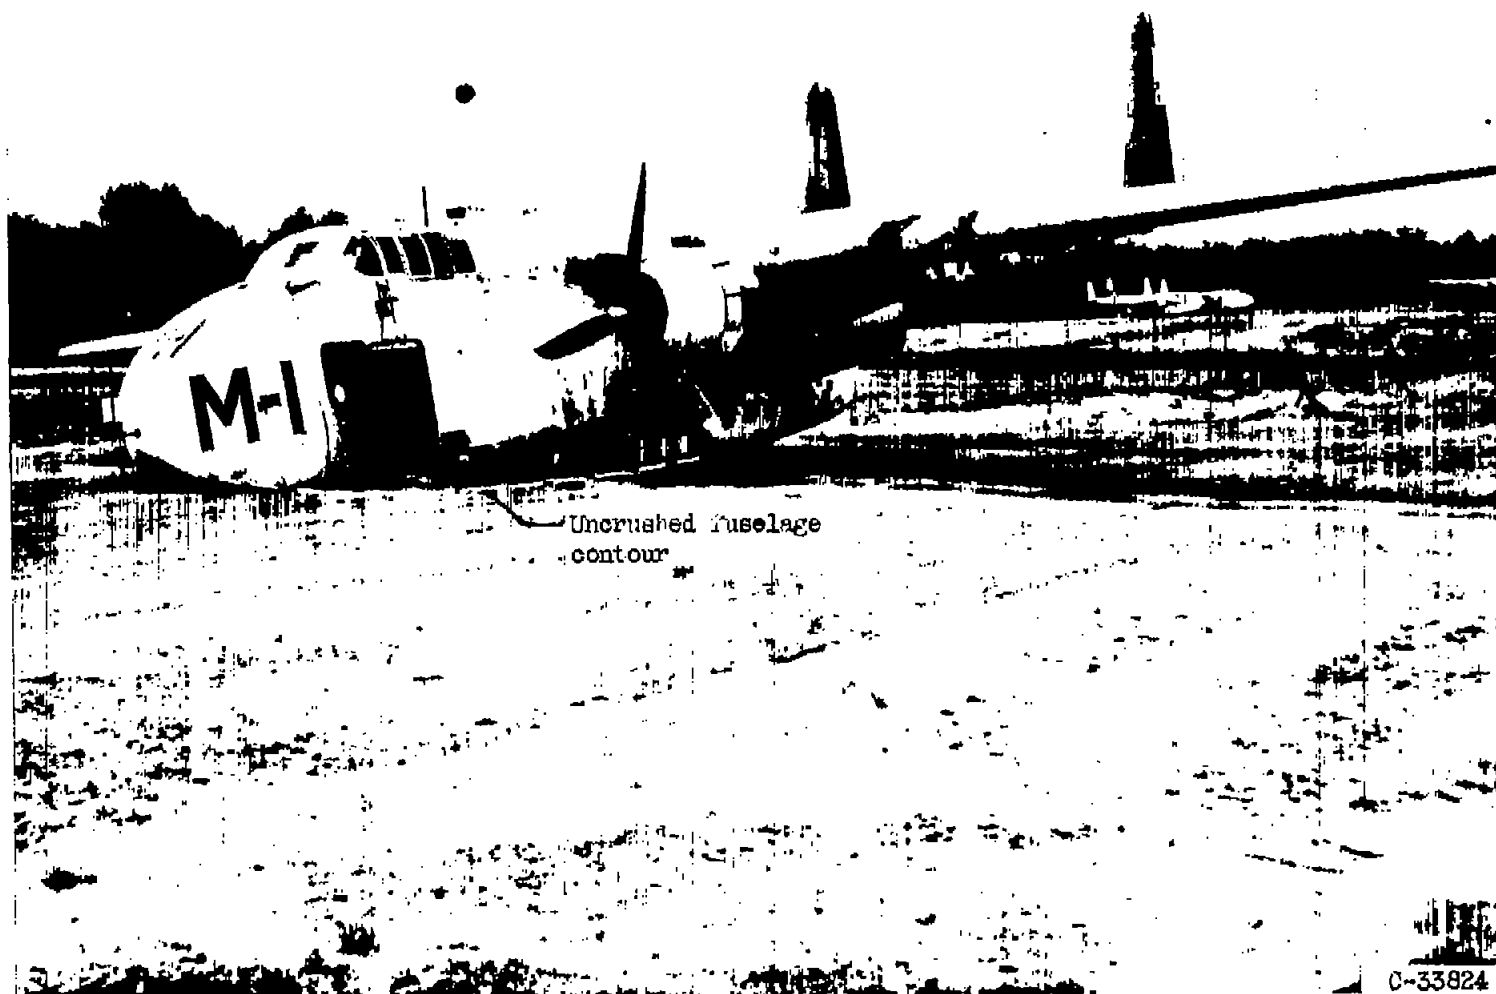
(b) Left side.

Figure 8. - Concluded. Crash-damaged fuselage of airplane.

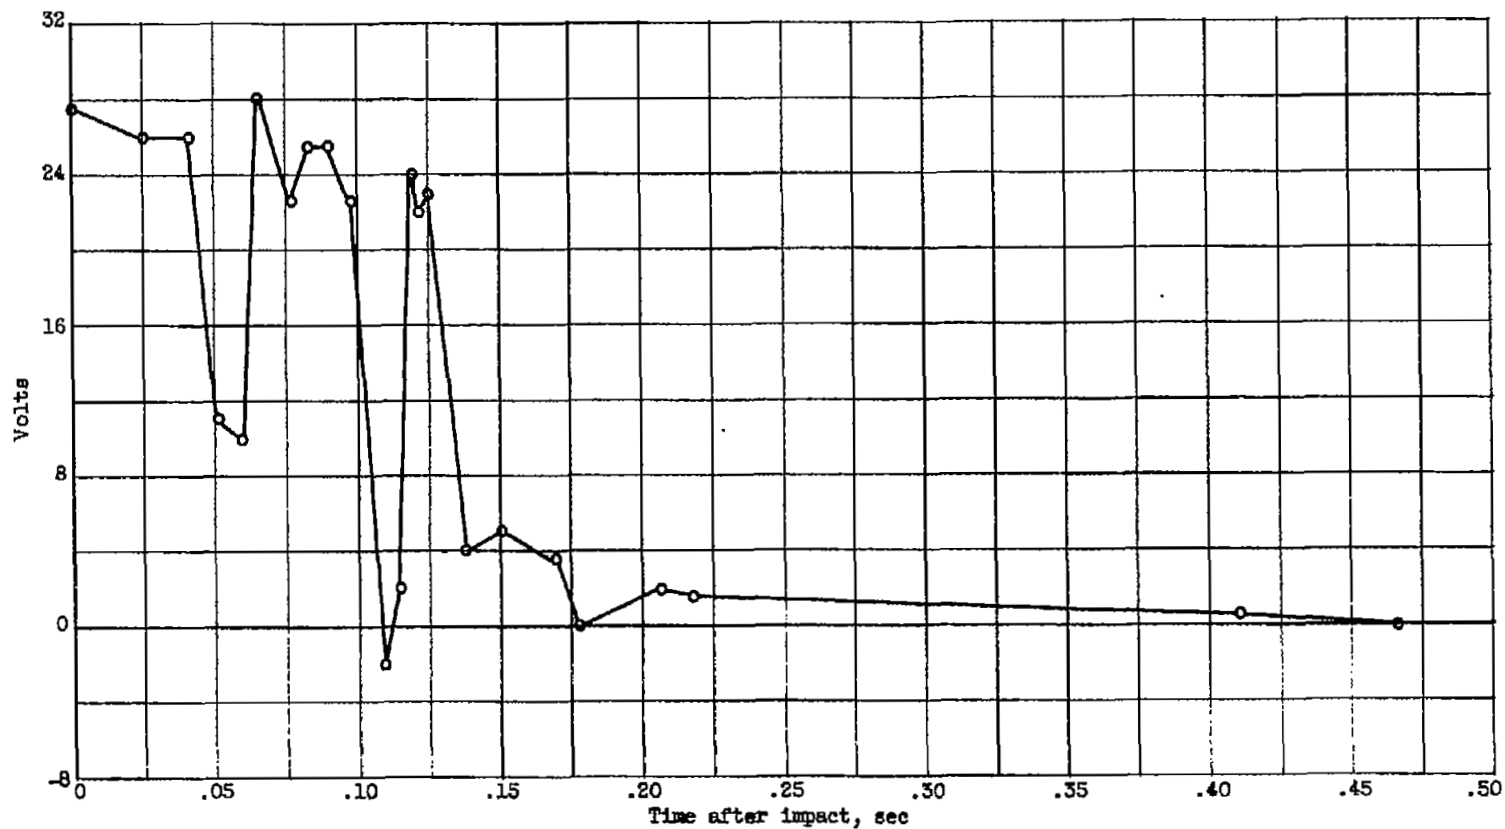
Electrical system de-energizing. - The variation of voltage in the airplane electrical system during the crash is presented in figure 12. Impact of the airplane with the first crash barriers occurred at time zero. Two sharp reductions in voltage occurred at approximately 0.05

and 0.11 second after impact. These reductions in voltage were caused by short circuits when the generators were torn from their mountings. The relays in the inerting system that disconnect the generators and battery from the airplane electrical system opened at 0.12 second after impact. The airplane voltage began to drop immediately thereafter. Part of the voltage drop after 0.12 second was the result of this relay action. Closing of a relay that grounds the power circuit (shortly after the batteries and generators are disconnected) hastened this voltage reduction. The grounding relay is actuated by the inerting system.

The electrical de-energizing action was complete when the voltage (fig. 12) reached zero at 0.178 second after impact. The 2-volt rise in potential thereafter could have been caused by the generator effect of coasting motors. Although the energy represented by this resurgence of voltage may be marginal as an ignition source, it should be prevented by means of a better grounding system, as discussed in the following paragraph.

Figure 12. - Variation of voltage in airplane electrical system.

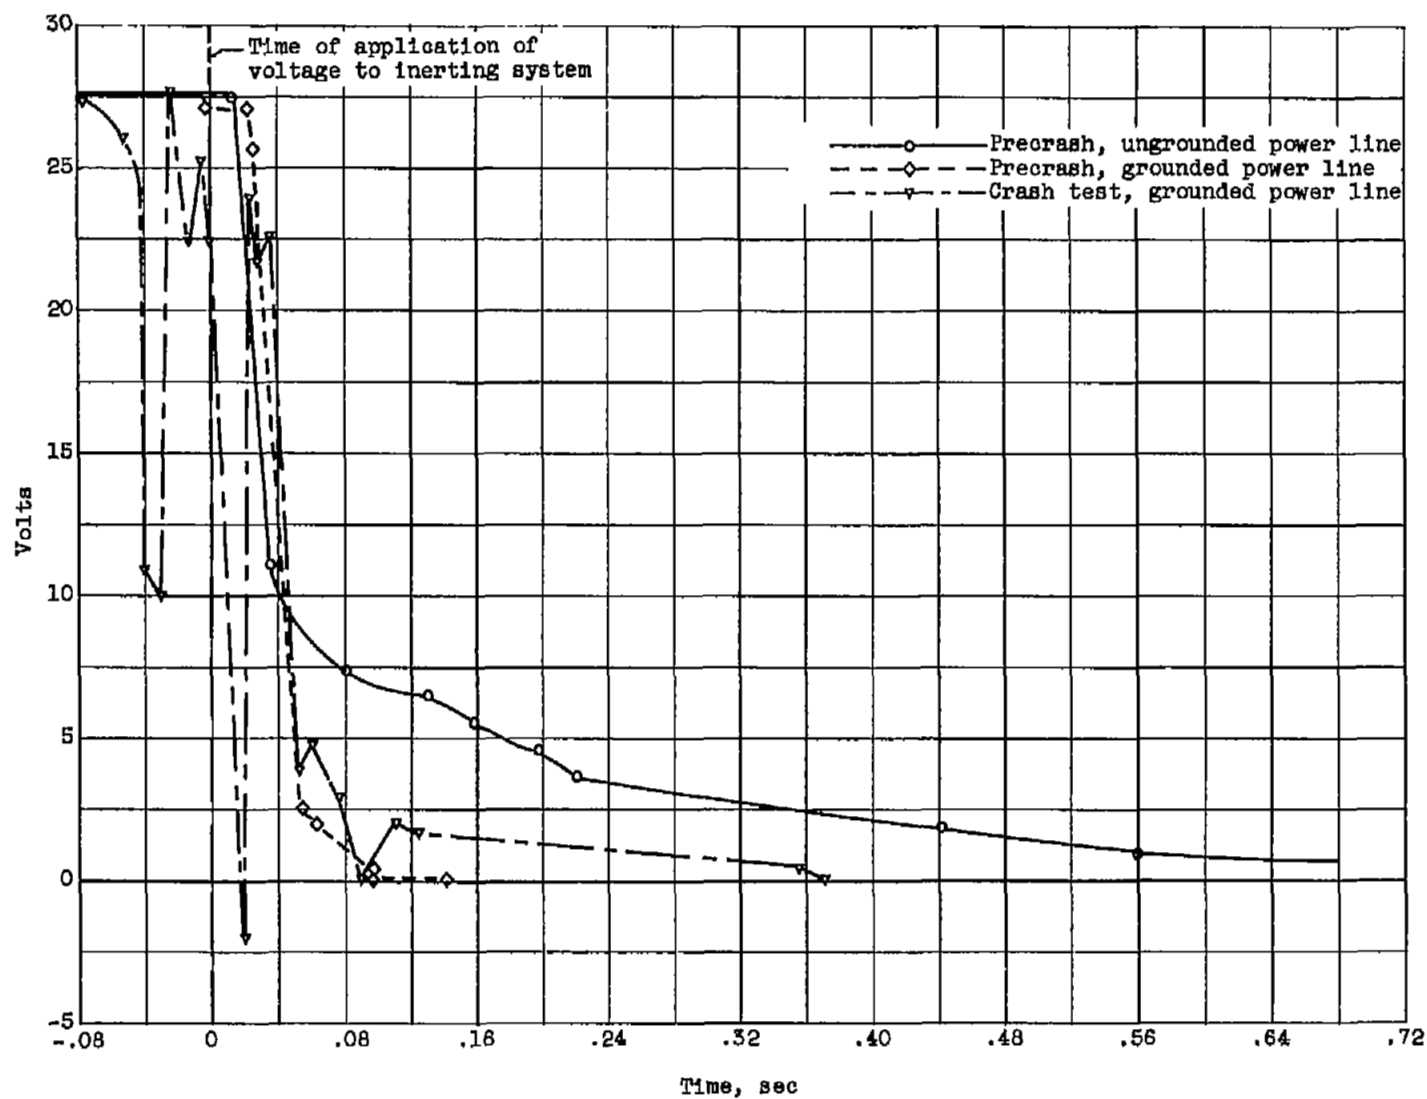
The effect of the grounding relay in the fire-prevention system on the airplane electrical system voltage is shown in figure 13. The voltage variations recorded during this crash are compared with those obtained in precrash trials of the electrical inerting system with and without a grounding relay. It can be seen from this figure that zero potential is obtained in a much shorter time with a grounding relay. The grounding relay used in the crash study had smaller contacts and lighter contact pressure than the relay used in the precrash studies. Because of these differences, the voltages in the precrash studies reached zero 0.25 second sooner than in the crash. In figure 13 "zero" on the time coordinate is defined as the moment at which voltage was applied to the inerting system.

Figure 13. - Effect of grounding on airplane electrical system voltage.

Short circuits, such as occurred in this crash, could prevent proper functioning of the fire-prevention system. For this reason, a suitable method should be devised to prevent short circuits in the airplane electrical system from influencing the output of the battery to the inerting system. If the battery is disconnected from the airplane electrical system before take-off or landing, short circuits in the airplane electrical system could not damage the battery. Therefore, the battery will have full potential to operate the fire-prevention system. Disconnecting the battery would not appreciably affect the airplane electrical system because the generators are generally large enough to meet all electrical requirements.

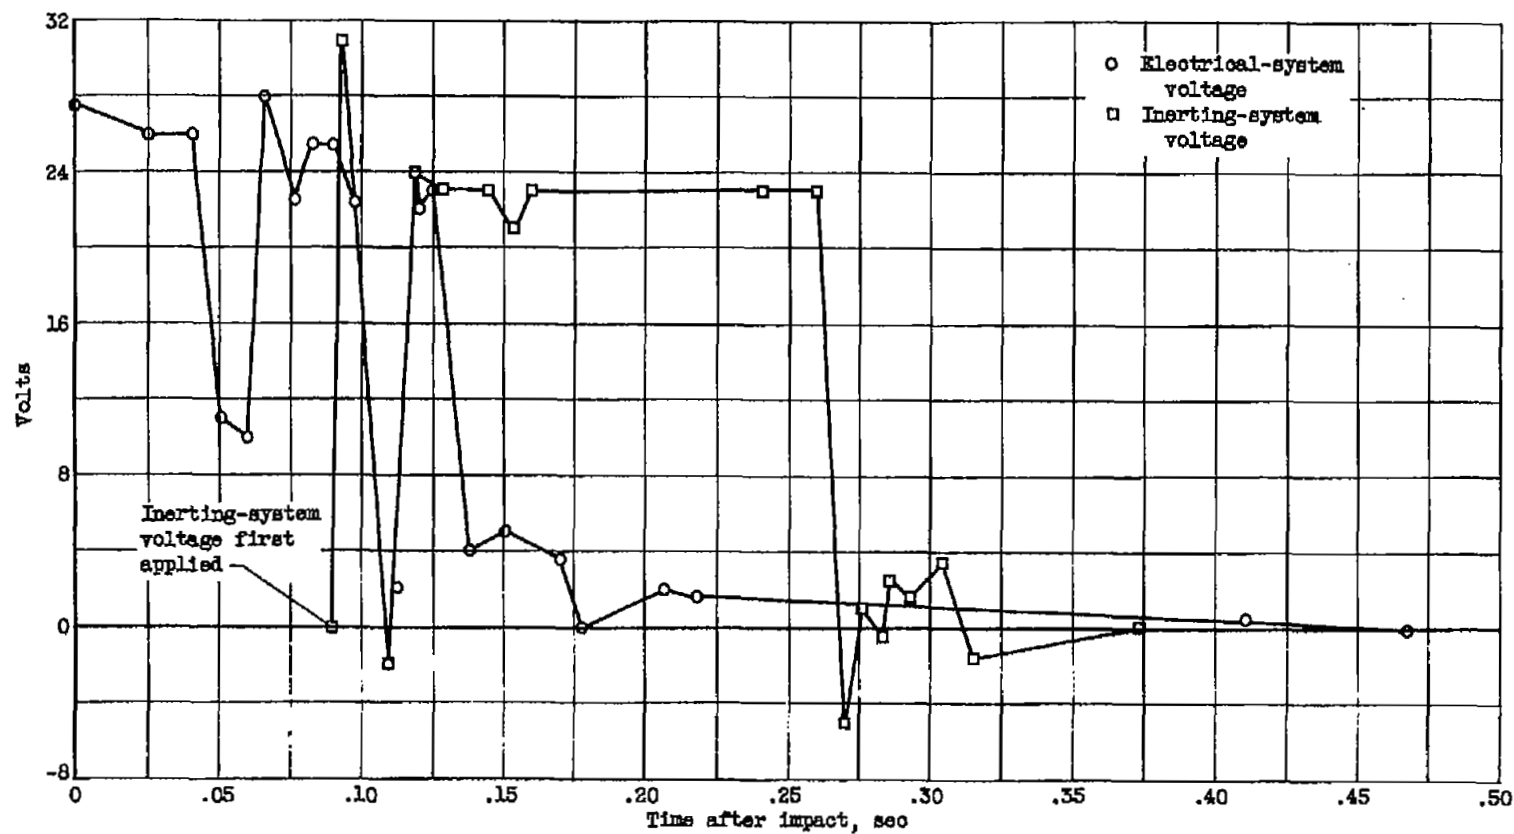
Inerting-system voltage. - The effect of the short circuits in the airplane electrical system on the voltage applied to the inerting-system components is presented in figure 14. The initiating system first applied voltage to the inerting-system components 0.09 second after impact. The second short circuit in the airplane electrical system occurred immediately thereafter and reduced the inerting voltage to zero, which delayed

the action of part of the inerting system. However, this short circuit quickly disappeared and both the airplane-electrical-system and the inerting-system voltage increased to battery potential (23 volts). The inerting-system voltage then remained at 23 volts from approximately 0.12 to 0.26 second after impact. At 0.26 second after impact the time-delay switch opened the circuit from the battery to the inerting system. The inerting voltage reached zero 0.27 second after impact and the inerting system wiring could then no longer act as a potential ignition source. The varying voltage after 0.27 second was due to inductive effects in valve and relay coils.

Figure 14. - Effect of short circuits in airplane electrical system on voltage applied to inerting-system components.
